**WEBER HILL TERRACE LAKE DAM
JEFFERSON COUNTY, MISSOURI
MO 30449**

PHASE 1 INSPECTION REPORT NATIONAL DAM SAFETY PROGRAM

Name of Dam: Weber Hill Terrace Lake Dam
State Located: Missouri
County Located: Jefferson
Stream: Bear Creek
Date of Inspection: 19 July 1978

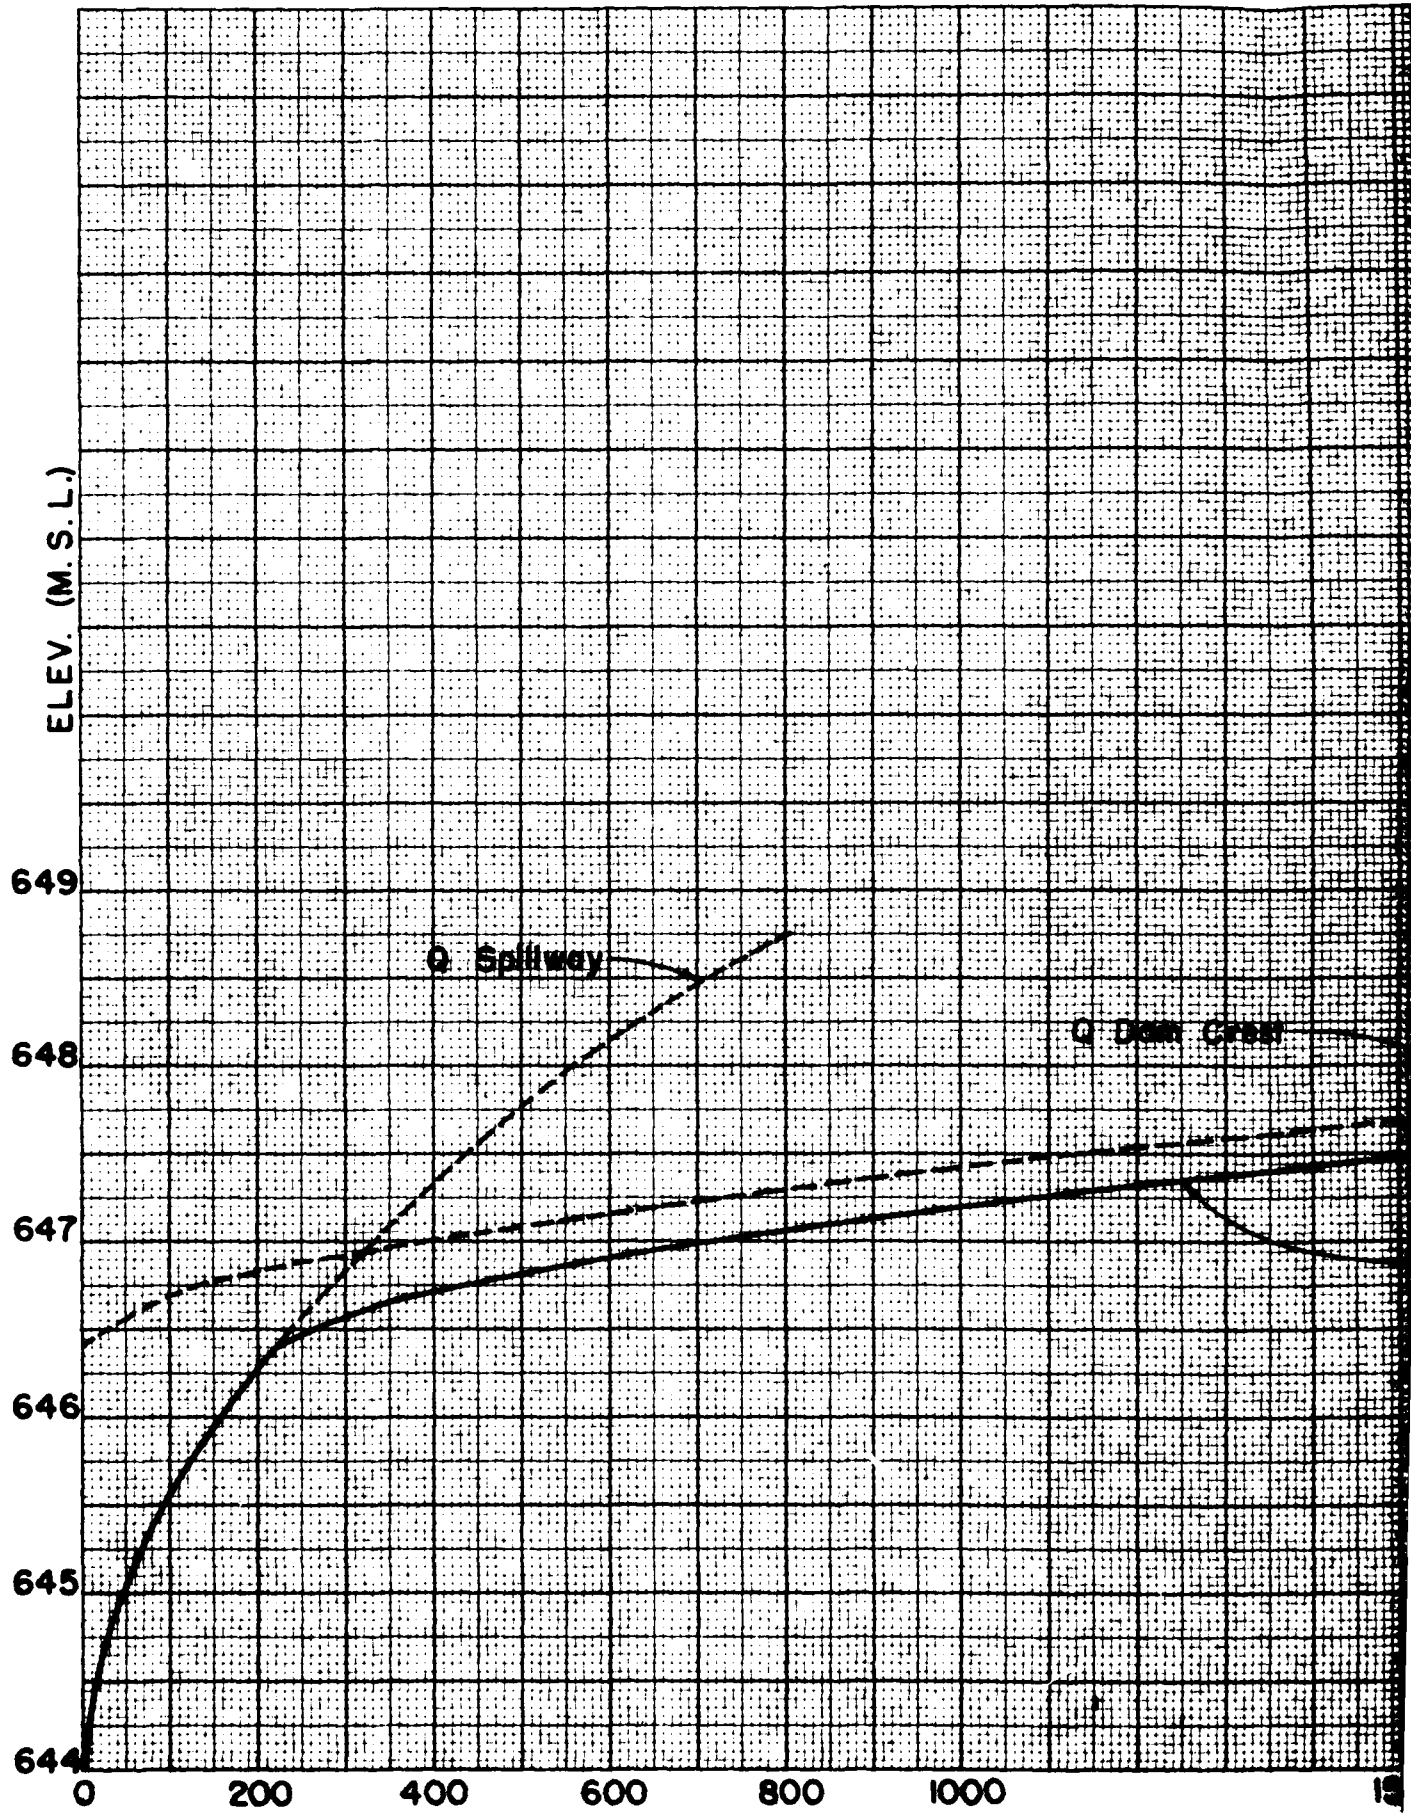
WENDEL TERRACE LAKE
DISCHARGE RATING CURVE

3. The profile of the dam crest is irregular and flow over the dam crest cannot be determined by conventional weir formulas. Flow quantities overtopping the dam crest were computed as described in the preceding paragraph and corresponding flow over the dam and spillway for given elevations were added to obtain the combined outflow rating curve for the dam and spillway. This rating curve is shown on Plate 4. The inflow and outflow hydrographs for the PMF are shown on Plate 5.
